# **SANDIA REPORT**

SAND2002-0730  
Unlimited Release  
Printed March 2002

## **Building, Testing, and Post Test Analysis of Durability Heat Pipe #6**

Timothy A. Moss

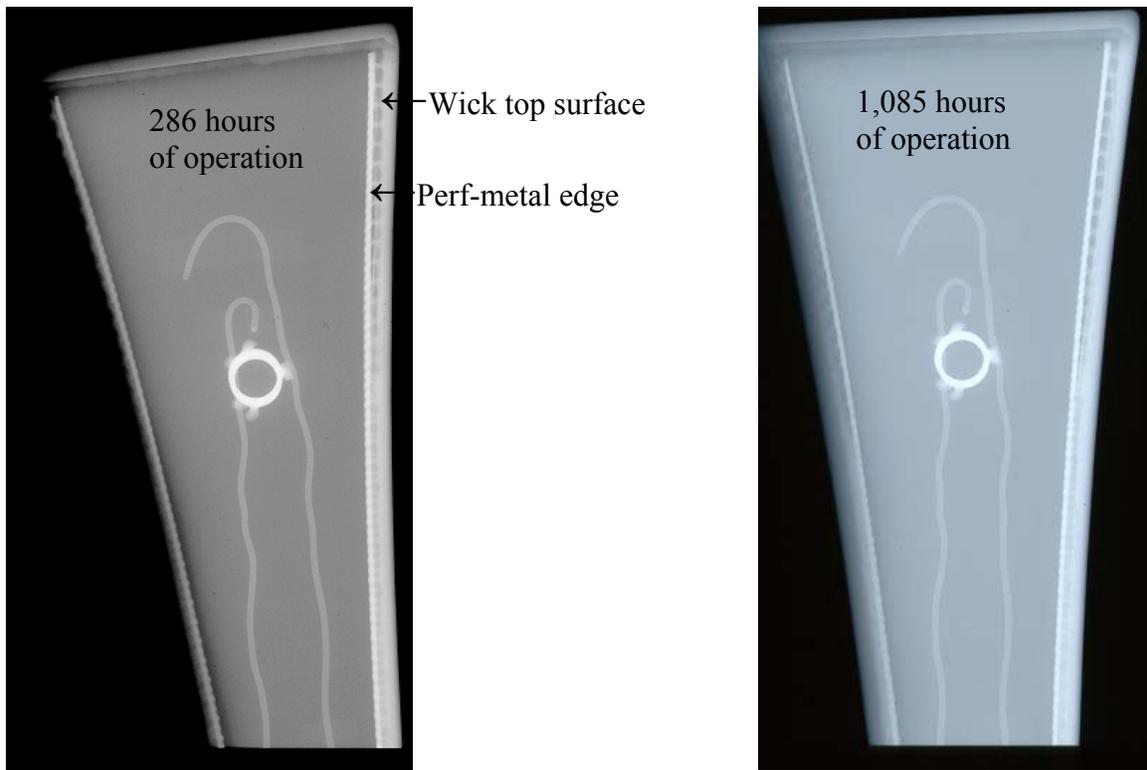
The heat pipe successfully completed 5,003.9 hours of testing at the operating temperature of 750°C between 6/9/2000 and 4/23/2001. There were 14 cold restarts (heat pipe was less than 200°C) and 3 hot restarts (heat pipe >300°C) during the testing period. Most of the cold restarts were caused by power outages. X-rays were taken of the top third of the heat pipe after 286 and 1085 hours of operation, as shown in figure 5. Notice the wick compression on the right side of each image shown in figure 4. The x-rays taken after 1085 hours of operation showed the wick was compressing and detaching from the perf-metal farther down over time. But as mentioned earlier, this was not a concern since the test was to determine the effects of a high temperature bakeout for reducing wick corrosion and not wick adherence to the perf-metal

Figure 5: Two X-ray images of the top section of durability heat pipe #6, the left one after 286 hours and the right one after 1085 hours of operation. The two fishhook like objects in each picture are the metal-sheathed thermocouples spot-welded to the flat hourglass shaped sides. The round object in the center of each is the 1/2" tube welded in the inside to prevent the heat pipe from collapsing during welding. For both pictures the evaporator side is the right side of the heat pipe.

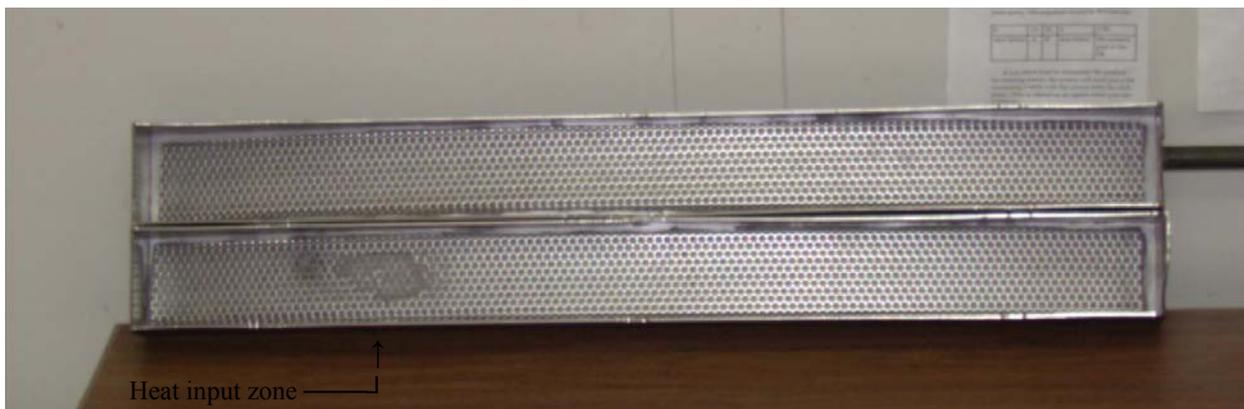
The heat pipe was cut open using a slit cutter with no lubricants in Sandia's machine shop. The cut was made down the center of the hourglass shaped sides lengthwise and through the end caps to preserve the two sides with the wicks. No lubricant was used as a safety measure in case sodium was still present in the heat pipe and also not to contaminate the wick on the two curved surfaces. Figure 6 shows a picture of the two halves of the heat pipe after being cut open. In figure 6, the bottom half is the evaporator side and the left side corresponds to the top. The area of discoloration on the left side bottom half is the heat input zone and is caused by contamination. This is the only area showing visible signs of contamination.

Figure 6: Picture of the two halves of durability heat pipe #6 just after being cut open. The left side is the top and the bottom half is the evaporator side. The discolored area on the left side bottom half is the heat input zone.

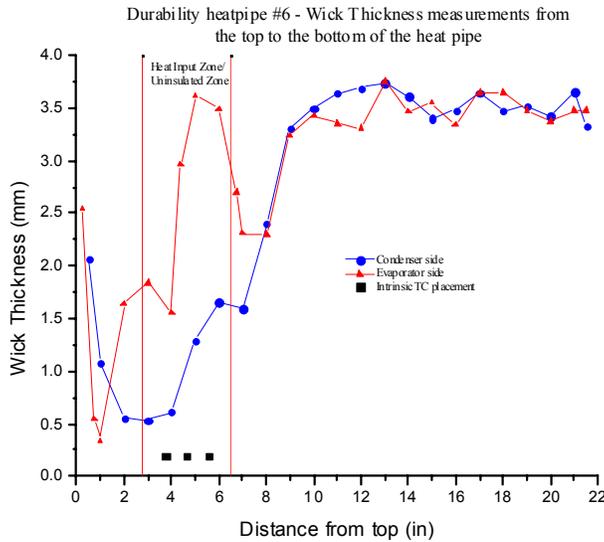
After the heat pipe was cut open wick thickness measurements were taken down the center of the wick along the full length of both the evaporator and condenser wicks. The results are shown in figure 7. Note how the wick is compressed in the heat input zone. Both wicks were also completely separated from the perf metal starting from the top to about the middle of the heat pipe.

Figure 7: Graph showing the wick thickness of both wicks along the length of the heat pipe

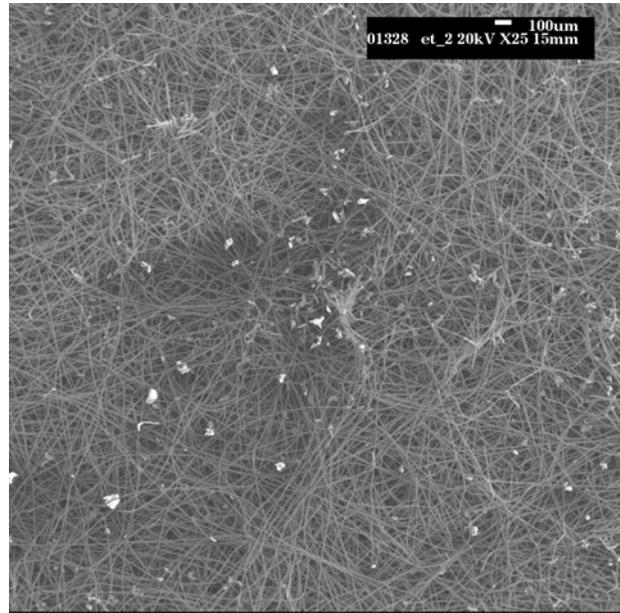
Figure A20: SEM picture of the evaporator top wick sample at 25x. The particles seen are from cutting out the sample from the wick.

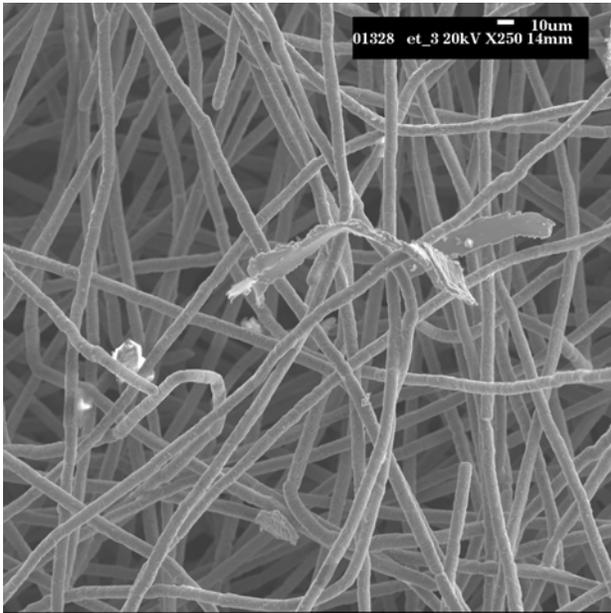
Figure A21: SEM picture of the evaporator top wick sample at 250x. The particles seen are from cutting out the sample from the wick.

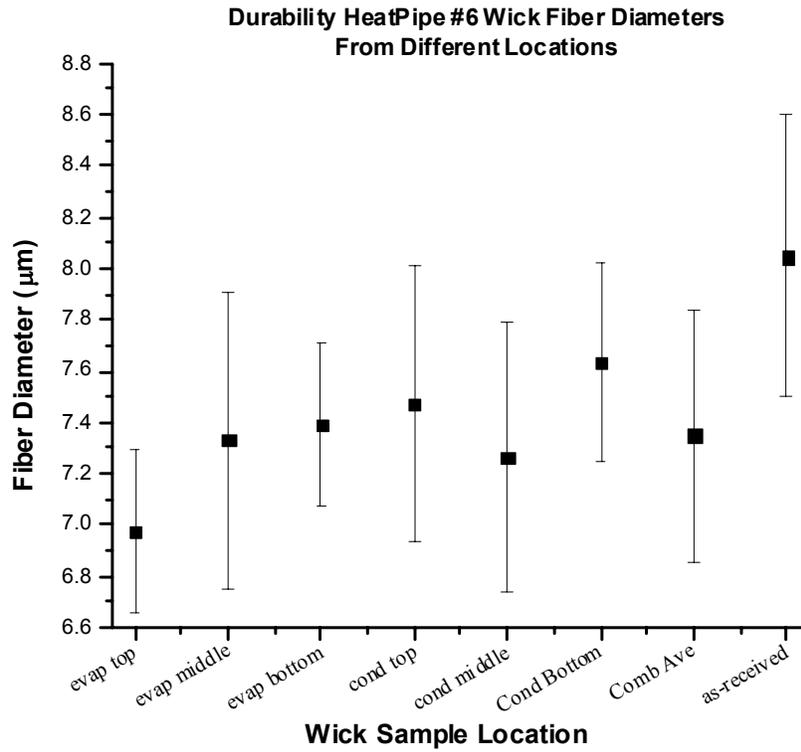
Using the SEM, measurements of the fiber thickness were taken of several fibers at multiple places from the three wick samples (top, middle, and bottom) removed from the evaporator and condenser side of durability heat pipe #6. Figures 1 thru 6 show the measurements taken using the SEM. For comparison, SEM measurements, shown in Figure 7, also measured fibers from the as-received 8/300 felt. The as-received fibers have a striation to them caused by the drawing process used to make the fibers. This pattern disappears during the sintering process, not by any effects from being exposed to sodium in the heat pipe. Figure 8 shows a plot of the average measured fiber thickness for each wick location, the average of the measured fiber thickness for all locations, and the average measured fiber diameter for the as-received felt. This plot shows there is very little difference in fiber thickness from the different locations in the heat pipe. For example, the average fiber thickness from all measurements on the condenser side is  $7.5 \pm 0.5\mu\text{m}$  and on the evaporator side it is  $7.2 \pm 0.5\mu\text{m}$ . The average measured fiber thickness from all locations in the heat pipe is  $7.3 \pm 0.5\mu\text{m}$ . The average measured fiber diameter for the as-received felt is  $8.0 \pm 0.5\mu\text{m}$ . The average fiber thickness in the heat is about 10% less than the as-received fiber thickness, but within one standard deviation, there is no difference between the as-received fibers and the fibers that had seen 5,000 hours in sodium at  $750^\circ\text{C}$ . The conclusion is there is very little corrosion of the wick fibers during the 5,000 hours of operation. This is a marked improvement over previous durability heat pipe tests with similar wicks that were made without a high temperature bakeout or reflux cleaning.

Figure B9: Plot showing the measured fiber thickness at each location showing one standard deviation

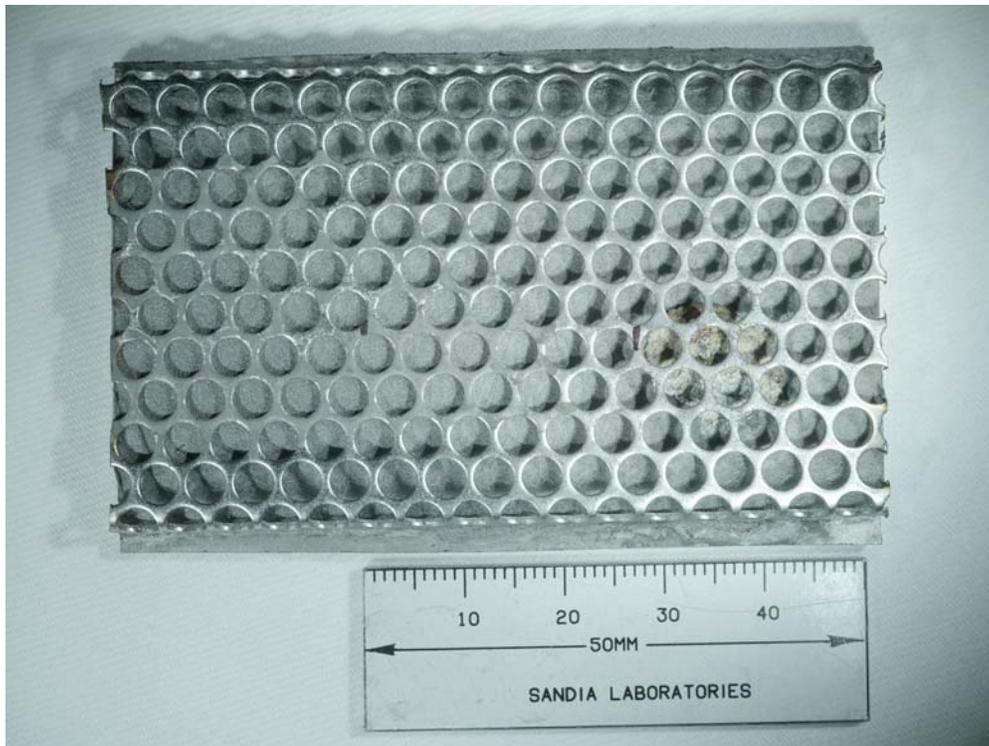
The entire heat input zone was removed from the durability heat pipe #6 for analysis using SEM and electron microprobe. Figures 1 and 2 show the entire heat input zone, the area directly in front of the lamp array, with the top being on the right side and the bottom of the heat input zone on the left. Figure 2 is the same as figure 1 but the perf-metal overlay was removed. The felt wick was not attached to the pert-metal except along the sides. The deposit on the top of the felt wick is more easily seen in figure 2. Figures 3 and 4 show the deposit at different magnifications. The actual location of the deposit is slightly above and on the opposite side of the intrinsic thermocouple used to monitor the surface temperature in the top part of the heated zone during testing. Using the electron microprobe, the deposit is mostly sodium and calcium oxide with some copper. The felt wick immediately around the edges of the deposit is discolored from the rest of the felt wick. The discoloration is caused by the surface of the fibers being enhanced with Fe and Cr, as compared to 316LSS. Previous analysis of as-received metal felt showed the fibers are within manufacture's specifications for 316LSS.

Figure D1: The entire heat input zone removed from durability heat pipe #6 with perf-metal overlay intact. In this picture the top of the heat input zone is the right side and the bottom is the left side.

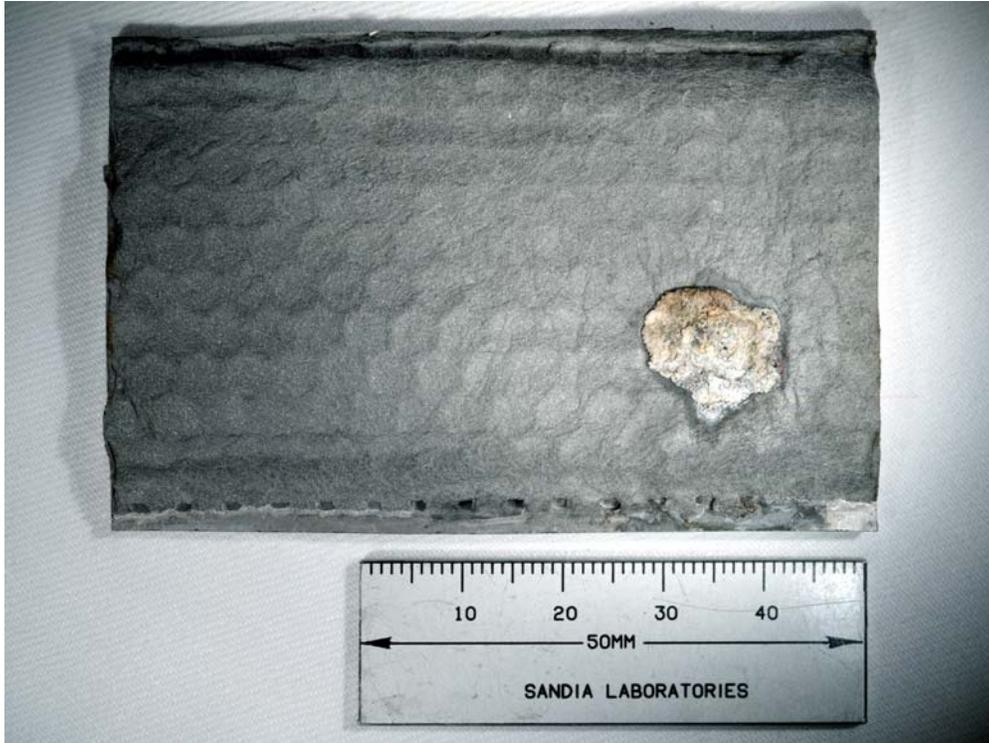
During analysis, the wick was peeled back from the substrate throughout the heated zone. The wick was firmly adhered to the substrate and to itself as it was hard to peel back and much of the wick was left behind on the substrate. Inside the wick starting just below the midpoint and extending about 1" vertically upward (in the direction of liquid flow), which includes the deposit on top of the wick, the wick was filled with a white powder. The electron microprobe showed this white deposit consisted of Ca and aluminum sulfate ( $\text{Al}_2(\text{SO}_4)_3$ ). The Ca most likely came from the sodium (13 ppm) since it is not listed as a component of any other material in the heat pipe. The sulfur most likely came from the 316LSS (0.3 weight%) since it is not listed in any of the other materials in the heat pipe. Ca and aluminum sulfate are not corrosive materials and no indication was found that these deposits affected the wall/wick bond or the sintering bonds between fibers. No deposits were found in the bottom half of the heated zone, just as in all the other wick samples from the heat pipe.

Copper was found spread out in the heat input zone inside the wick close to the substrate starting at about the midpoint and extending vertically up (in the direction of liquid flow) the wick about ½" forming thin crystals to a coating on the felt fibers. No copper nugget was found, however, either on top of or inside of the wick as was found in previously tested bench test heat pipes and capsule tests. There is some copper in the as-received sodium (10 ppm) but the largest source of

Figure D2: The entire heat input zone removed from durability heat pipe #6. This is the same as figure 1 but with the perf-metal overlay removed.

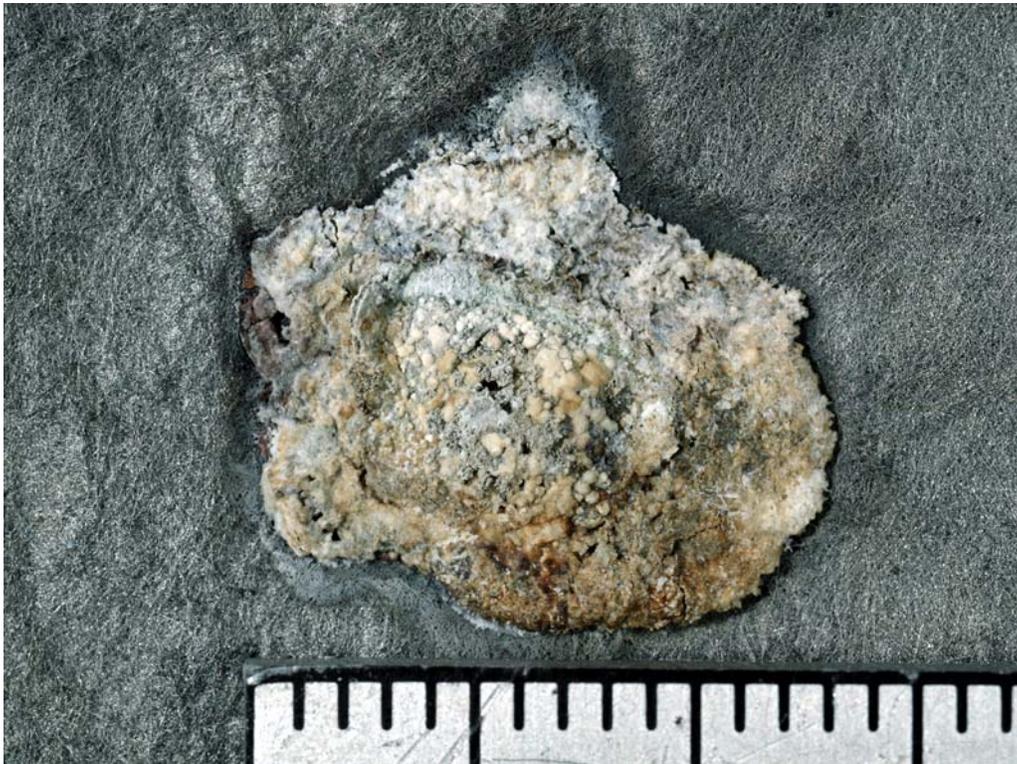
The deposit sitting on top of the wick contained one calcite crystal and some Si, but most of it was NaO that converted to  $\text{Na}_2\text{H}_2\text{O}_3$  (sodium hydroxide) after being exposed to air. The Si comes from all the materials present in the heat pipe, Haynes alloy 230 (0.25-0.75 weight%), 316LSS (1 weight%), and sodium (13ppm). When the concentration of NaO is 100ppm or greater it becomes very corrosive. The deposit sitting on top of the felt wick was stuck to the wick, but not firmly attached since it separated from the felt wick without leaving anything behind and not taking any of the fibers with it. The fibers underneath the deposit did not show any more corrosion or reduction in fiber thickness than any other area in the heat pipe. This indicates the NaO concentration was below 50ppm, or there was a buffer layer between the NaO and the felt wick such as the Ca and aluminum sulfate, described in the next paragraph, inhibiting corrosion of the felt wick from NaO.

Figure D3: Close up of deposit on top of the felt wick underneath the perf-metal.

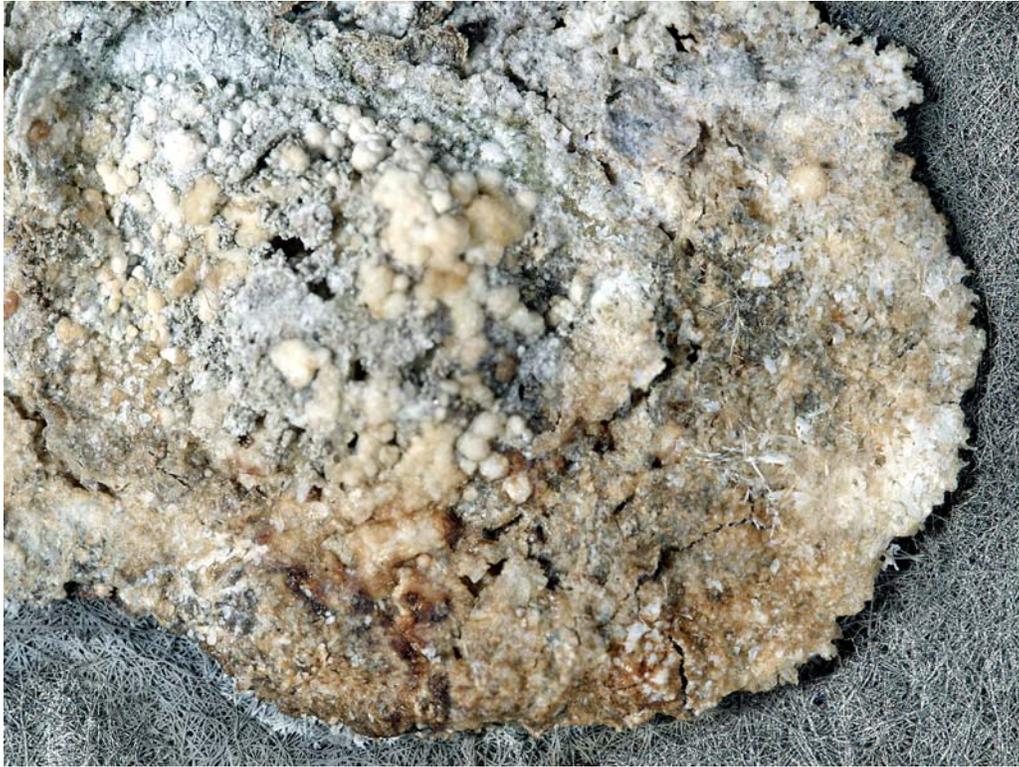
Figure D4: Higher magnification of the deposit sitting on top of the felt wick. This picture shows how the deposit does not appear to penetrate into the wick but is sitting on top of it.
